Manhole Inspection Summary

Manhole # S07OO1011MH

Insp Date: **5/18/09 11:21 AM**

Location Address: **5102 ELMER AVE**

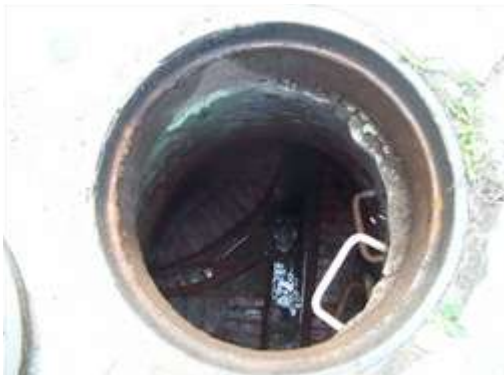
Top View

Frame Offset: **2** (in.) Condition: ☒ Sound ☐ Cracked ☐ Leaks

FRAME OFFSET

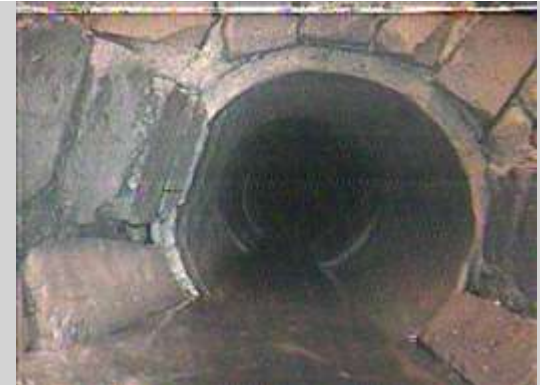
12 O'Clock Outflow

8 in. Circular Gravity Sewer
Pipe Out @ 12 O'Clock

Pipe Height: (in.) Direct
Pipe Material: **Clay** ☐ Pipe Lined
Invert Depth: **7.60** (ft.) Flow Characteristics: **Slow**
Deposits: ☒ None ☐ Mud ☐ Sludge ☐ Debris ☐ Grease
Silt Depth: (in.) Deposits Extent:
Infiltration: **None** Pipe Seal Cond: **Sound**

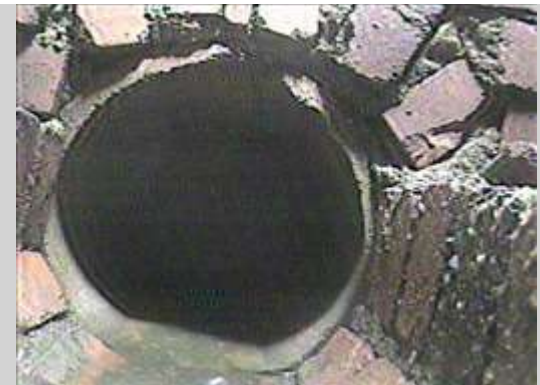
6 O'Clock Inflow

8 in. Circular Gravity Sewer
Pipe In @ 6 O'Clock

Pipe Height: (in.) Direct
Pipe Material: **Clay** ☐ Pipe Lined
Invert Depth: **7.65** (ft.) Flow Characteristics: **Slow**
Deposits: ☒ None ☐ Mud ☐ Sludge ☐ Debris ☐ Grease
Silt Depth: (in.) Deposits Extent:
Infiltration: **None** Pipe Seal Cond: **Sound**

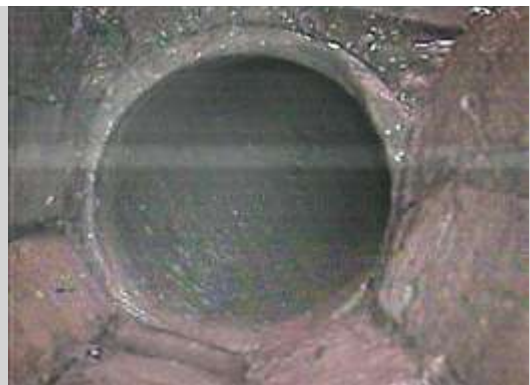
9 O'Clock Inflow

8 in. Circular Gravity Sewer

Pipe In @ 9 O'Clock

Infiltration: **None** Pipe Seal Cond: **Sound**
